Maryland Historical Trust

S-433

MD 364 over Durling Creek.

Name and SHA No. 19010 over Dividing Creek

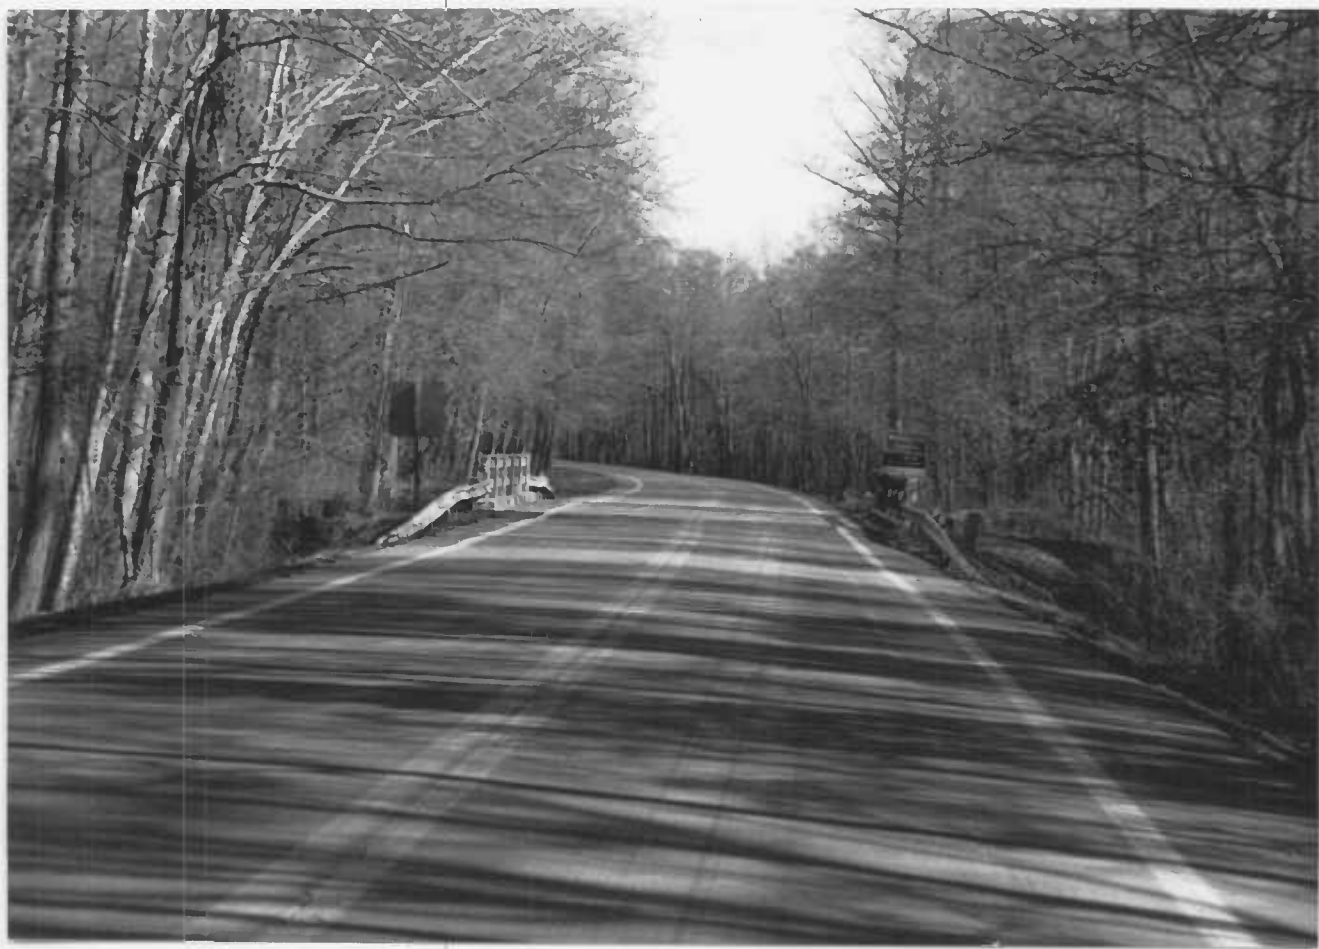
1 OF 5

BRIDGE 19010, LOOKING NE ON MD 304

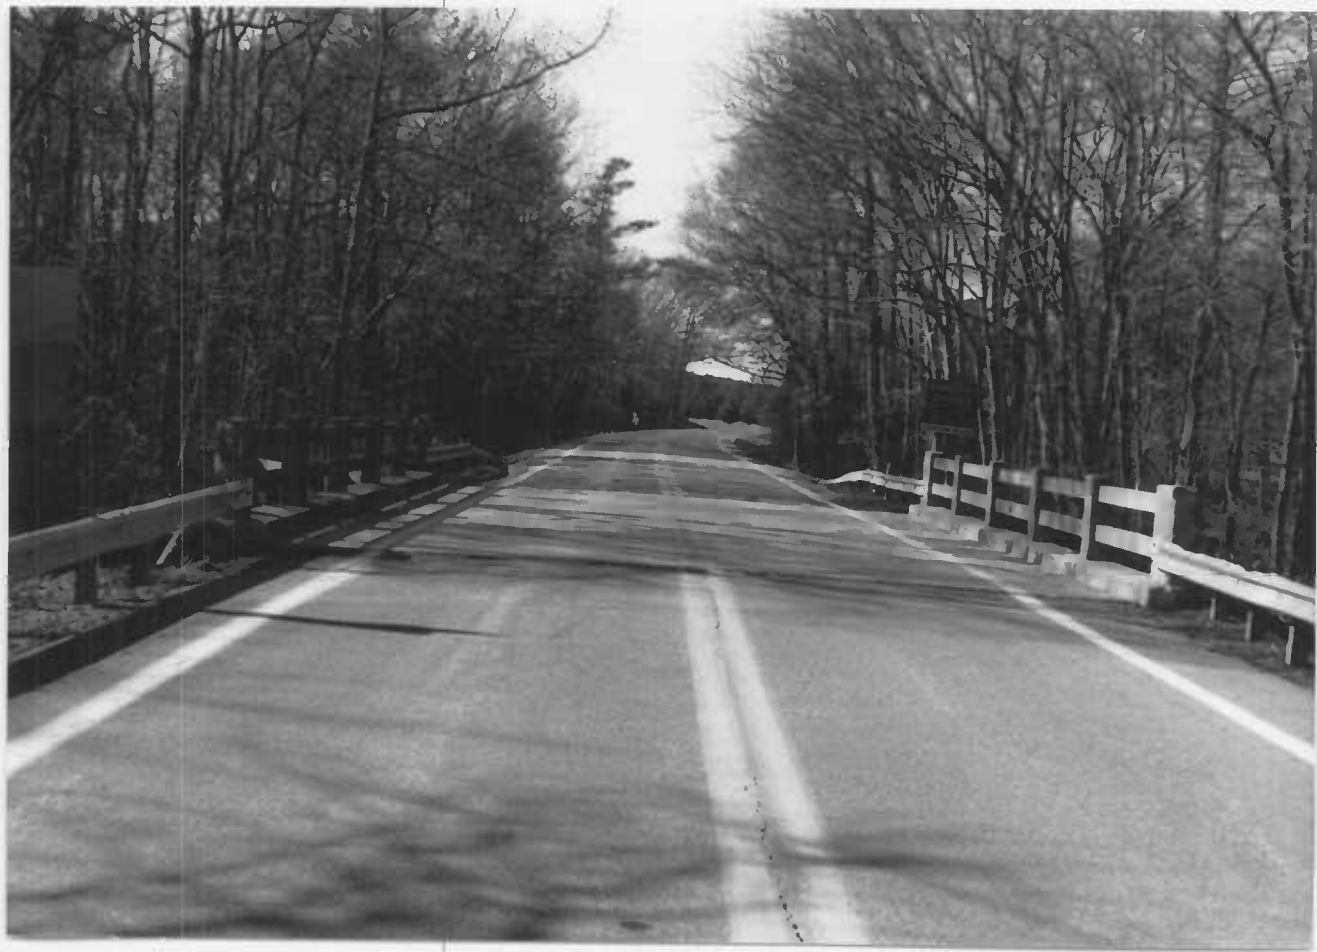
2 OF 5

BRIDGE 19010, LOOKING SW ON MD 364

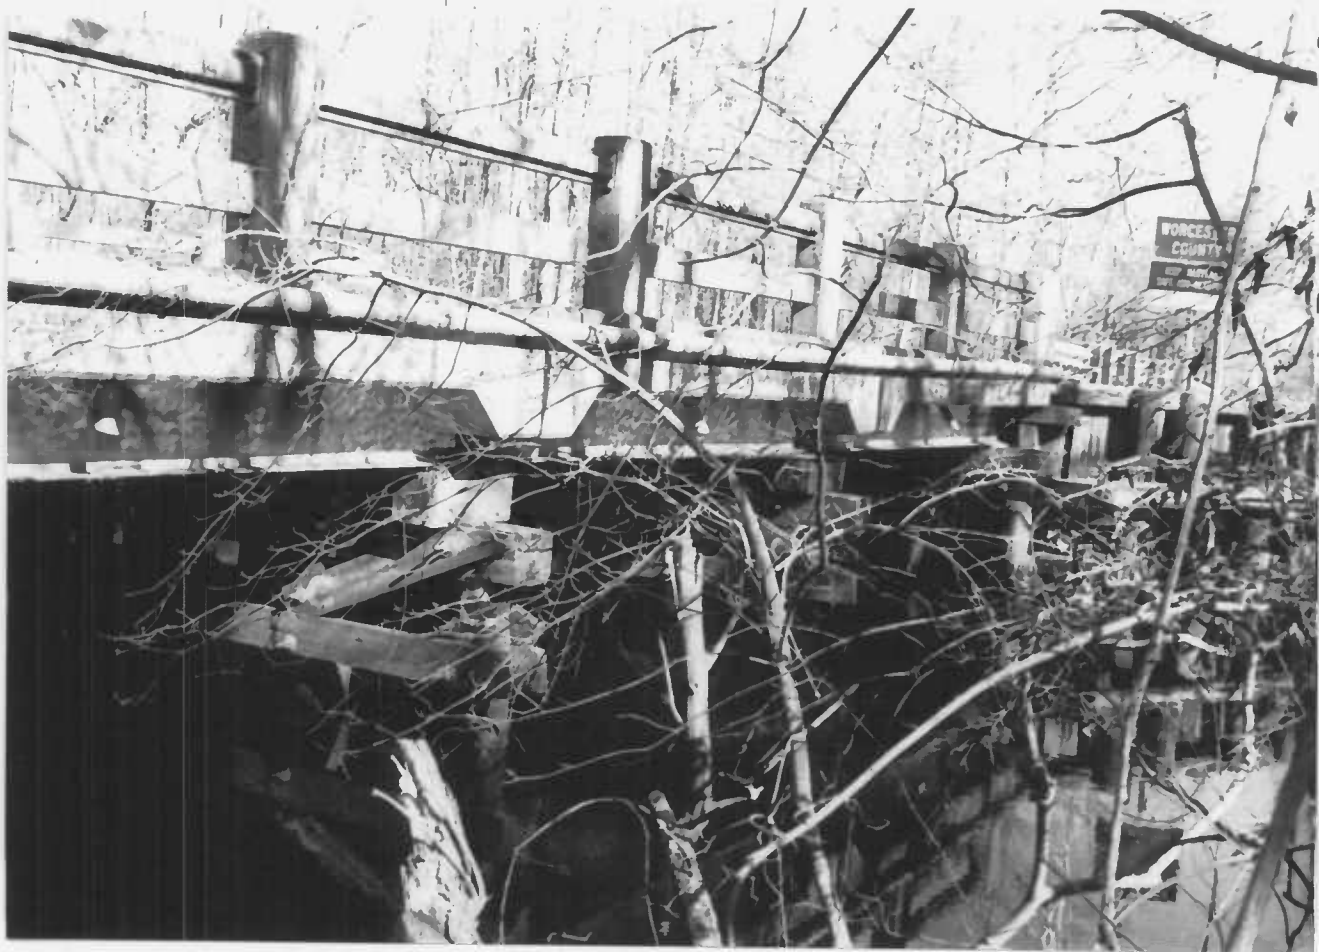
3 OF 5

BRIDGE 1901U, LOOKING UPSTREAM (NW)

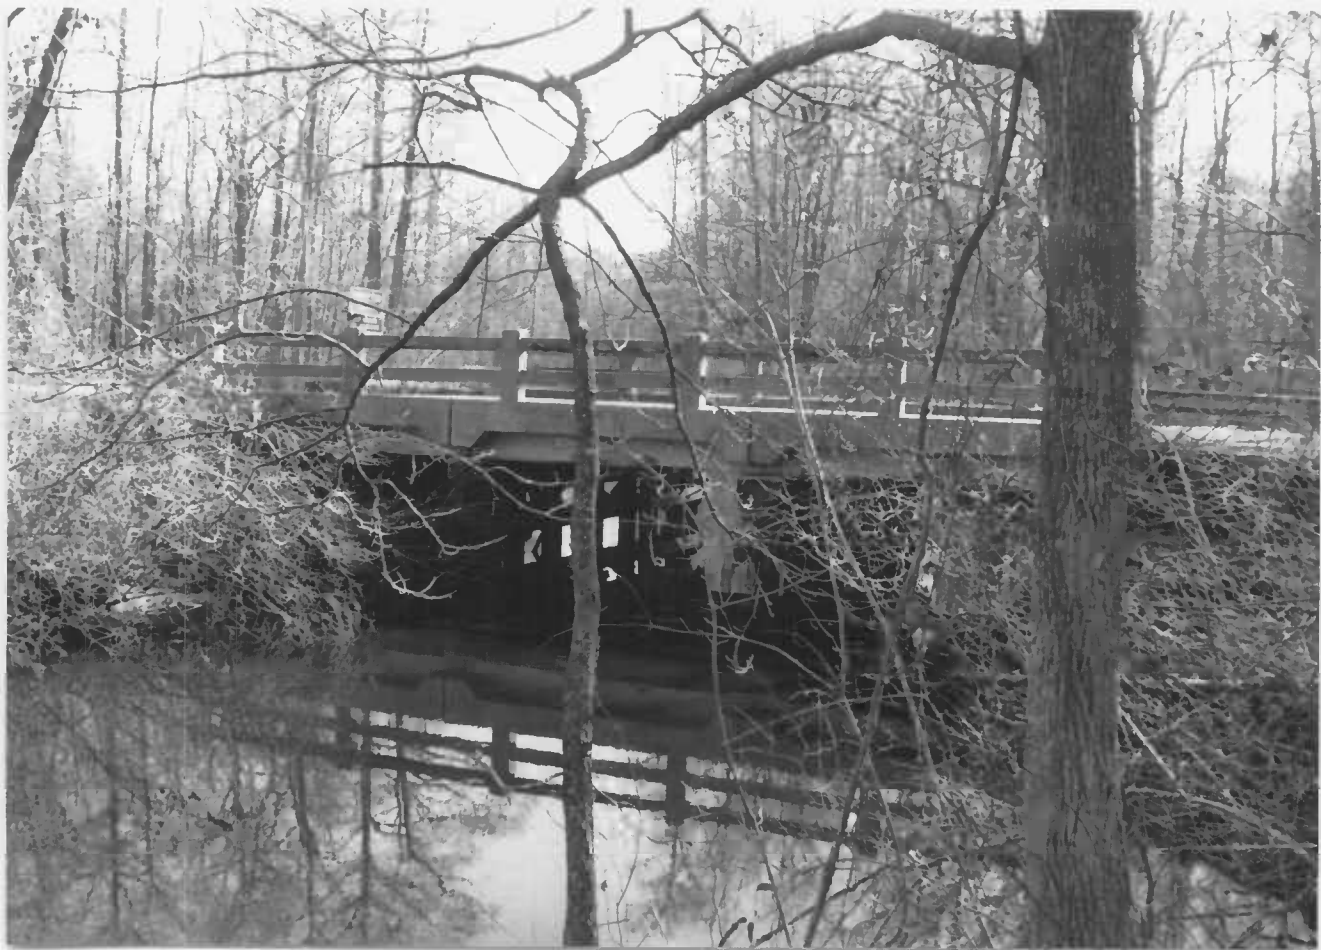
4 of 5

BRIDGE 19010, LOOKING DOWNSTREAM (SE)

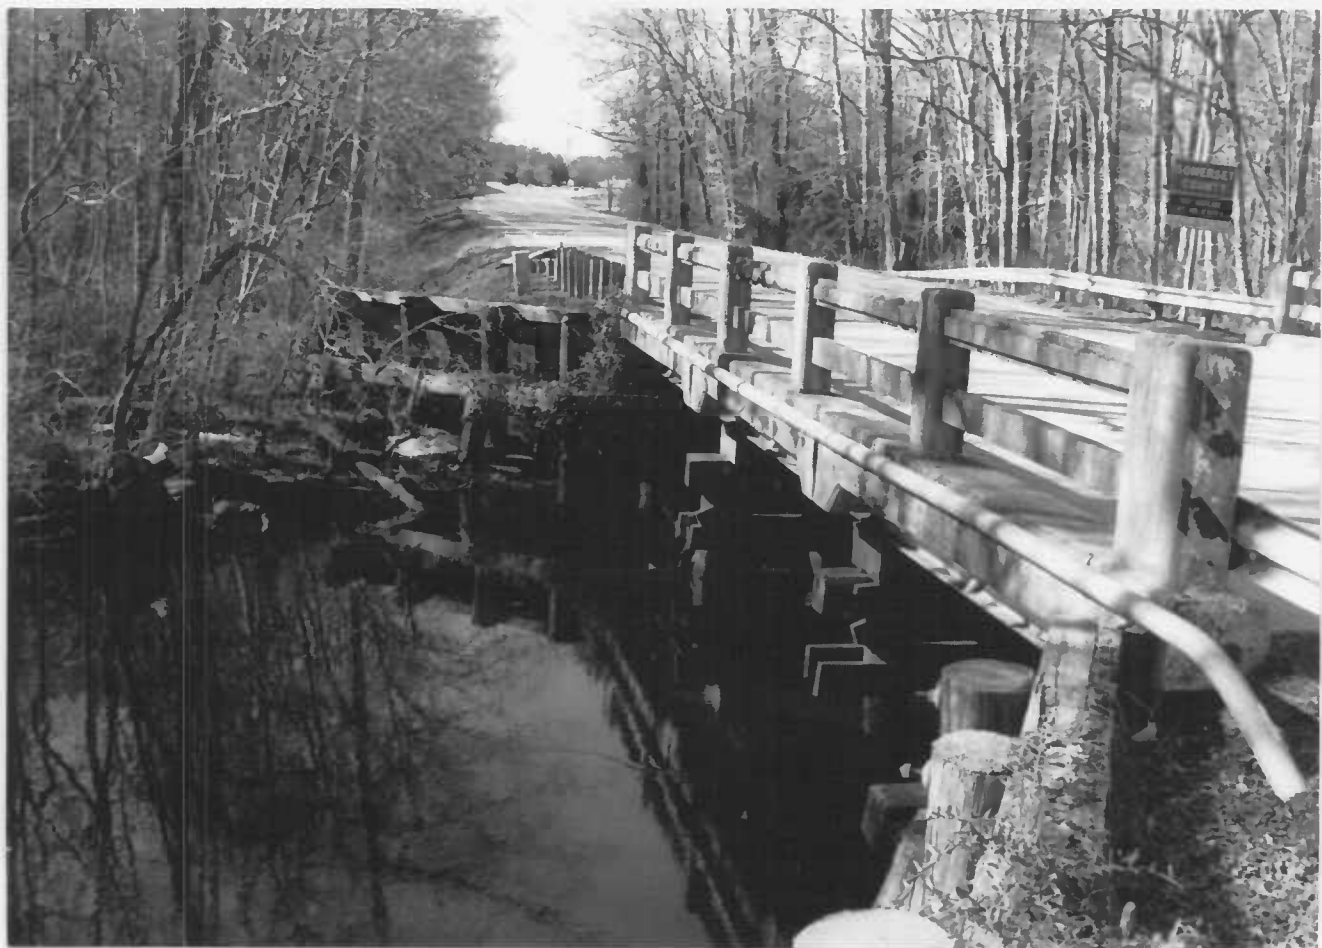
5 OF 5

BRIDGE 19010, LOOKING UPSTREAM (SW),
